# LONG-TERM EFFECTS OF HAIL IMPACT ON ASPHALT SHINGLES—AN INTERIM REPORT

**SCOTT J. MORRISON**  
Haag Engineering Co.  
Carrollton, Texas, U.S.A.

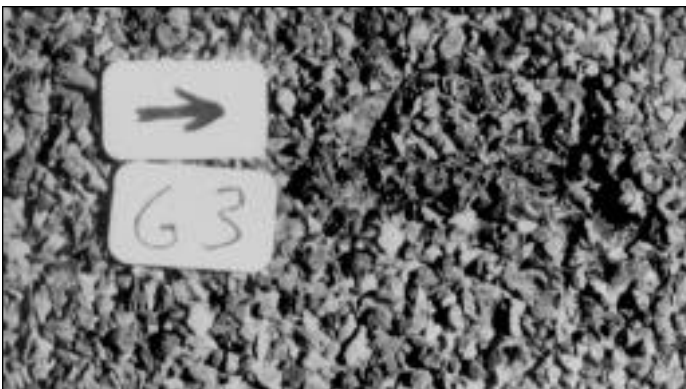
colored asphalt was visible at several locations in the laminated shingles impacted previously. With the blade of a penknife, these areas were probed and scraped carefully. A continuous bed of granules was detected immersed fully in asphalt. The frequency of fractures caused by impacts of 1-inch- (25-mm-) diameter freezer ice balls for all types of shingles tested in this study is presented in Table 7. Typical observations of an impact site with fractures are depicted at 10 years 6 months and 14 years 11 months in Photos 8 and 9, respectively. Photo 10 depicts asphalt underlaid with granules.

**Photo 9.** Close-up of Tab G-3, half-panel designation CO-FS-D-0 at 14 years 11 months weathering exposure. Note impact-caused fracture.

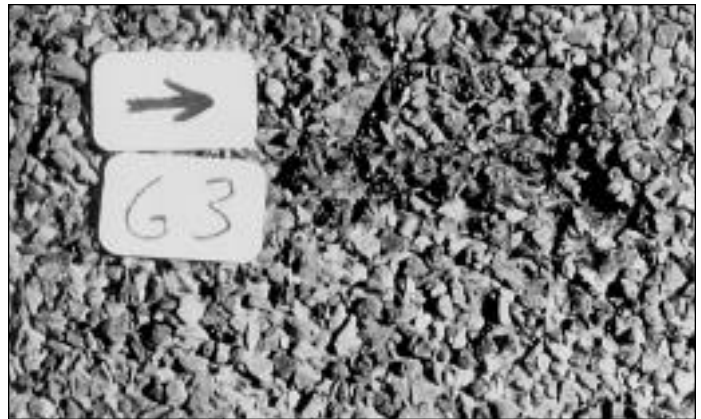
**Photo A4.** Close-up at fracture in Photo A3.

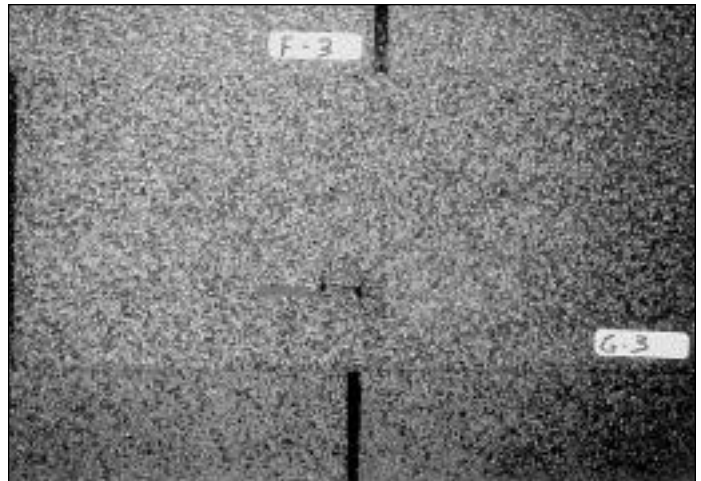
**Photo A5.** Close-up of Tab G-3 at 14 years 11 months weathering exposure. Note impact-caused fracture.

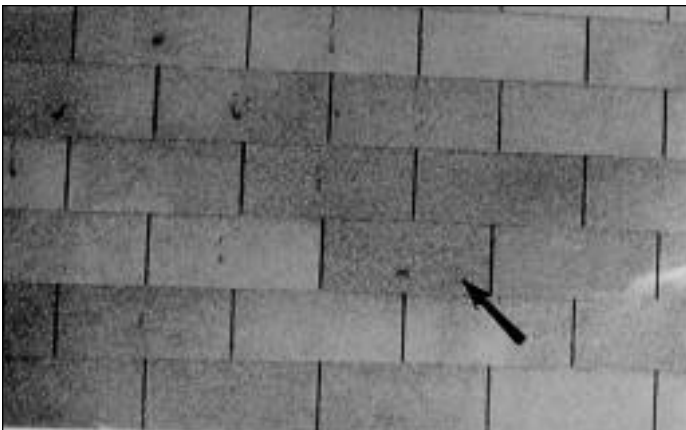
**Photo A2.** View of test panel at Year 0 after impacting. Note fracture in Tab G-3.
